**A PRELIMINARY DIAGNOSTIC STUDY OF ANDERSON PARK LAKES  
MADISON COUNTY, INDIANA**

**A Report for  
Parks and Recreation Department  
Planning Department  
City of Anderson**

**November 1999**

**Lake and River Enhancement Program  
Division of Soil Conservation  
Indiana Department of Natural Resources**

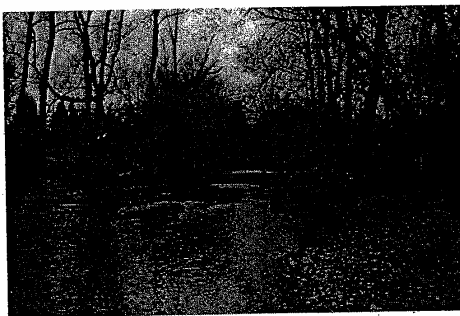
**Killbuck Creek above Shadyside Park Lake.**

The distribution of aquatic plants in Killbuck Creek is apparently controlled by riparian shading, stream bed material, and water velocity. Plants root better in soft muddy substrates than in hard rocky beds. Most aquatic plants are weakly constructed compared to land plants and prefer slow water or no flow. Aquatic plants were abundant on the streambed of Killbuck Creek in park areas downstream of the lake, but not in upstream areas. Downstream of the lake, Killbuck Creek is open to sunlight, has a soft bottom, and has fairly extensive network of side channels that are protected from fast flow. Upstream of the lakes, the creek has a dense riparian buffer of mature trees that shades the single deep channel that forms the creek. The bed consisted of sand and gravel. The study did not identify the reasons for the greater amount of sedimentation in the creek downstream of the lakes. Nutrient export from the lakes may also contribute to downstream plant growth.
